Pressure Vessel Assessment Report

Project Information		
Client: Total Energy	Location: Blackwell OK	Date: 7/23/2013
Contact:	Integrity Mgmt. Advisor: Chuck Easterbrooks - API 510 #2212	
Cc:	API / UT Inspector: Robert Van Pelt-API 510# 40899	
Vessel Description: Propane Storage Tank		
Vessel Identification: SN-1536

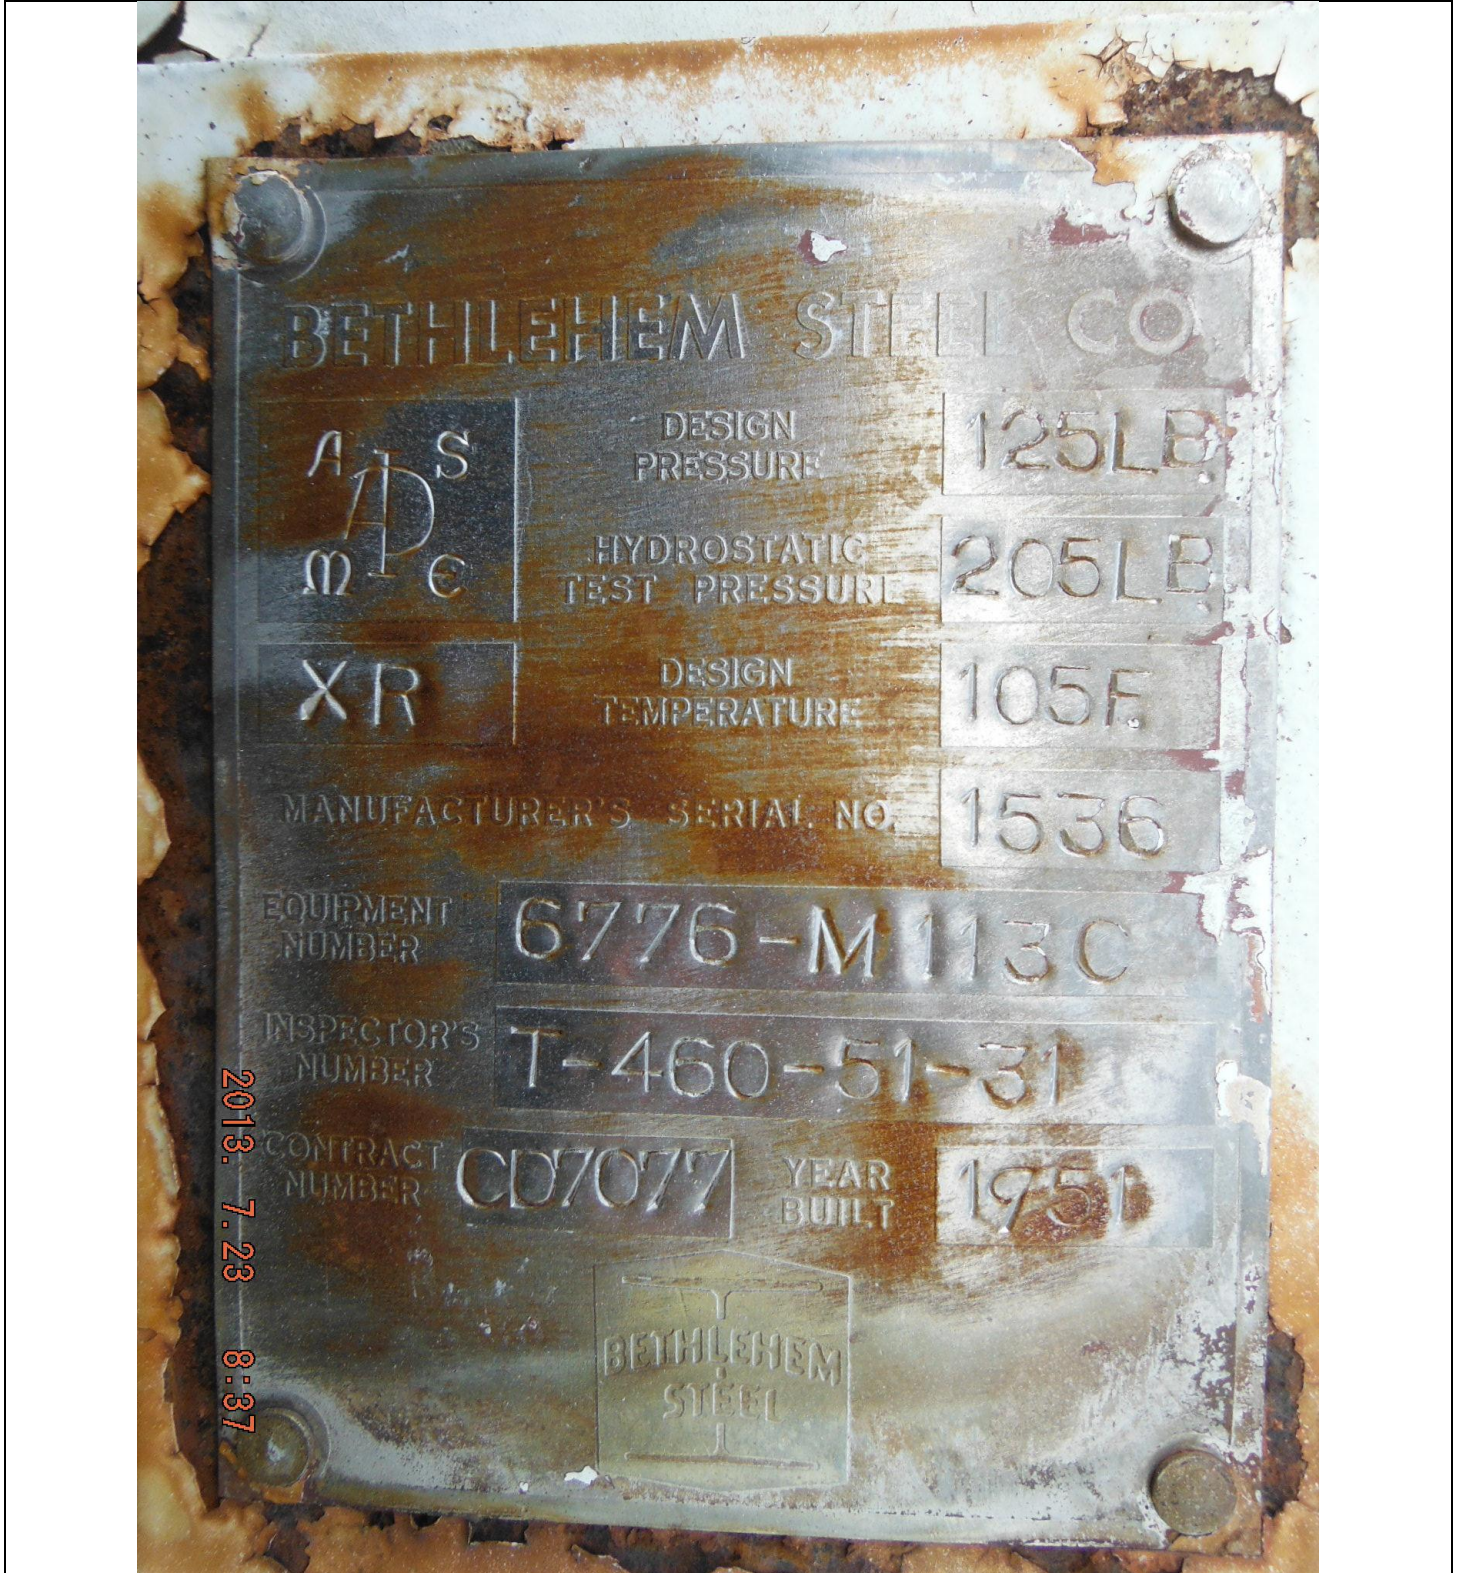
PICTURE 1 – DATA PLATE 1536

The data plate was intact and legible.

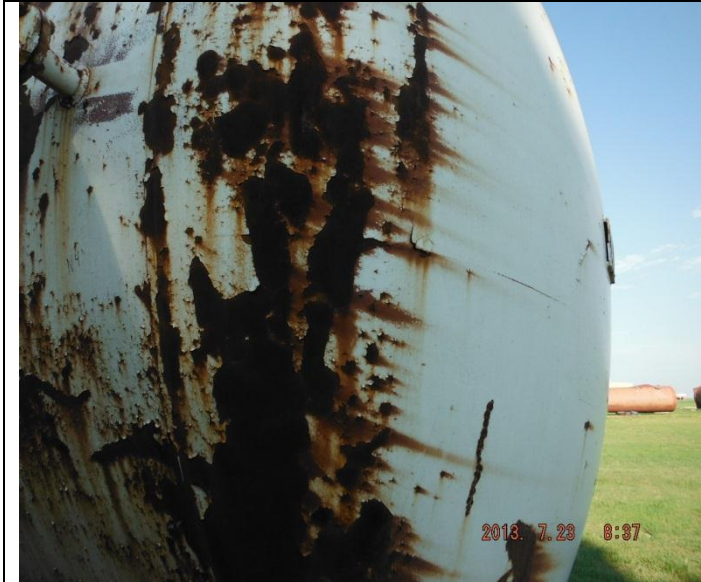
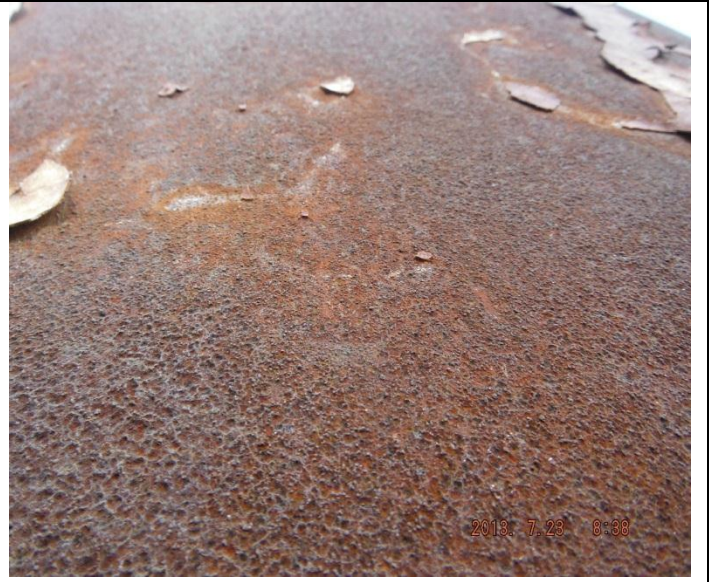
The north head had significant coating failure extending approximately 5 feet past the head to shell girth seam. The south head had scattered visible paint failure areas up to 1" in diameter throughout.

head corrosion 1536

The vessel should be abrasively blasted and painted to mitigate future external corrosion. All flange gasket surfaces should be mechanically cleaned and evaluated to ensure suitability for service.

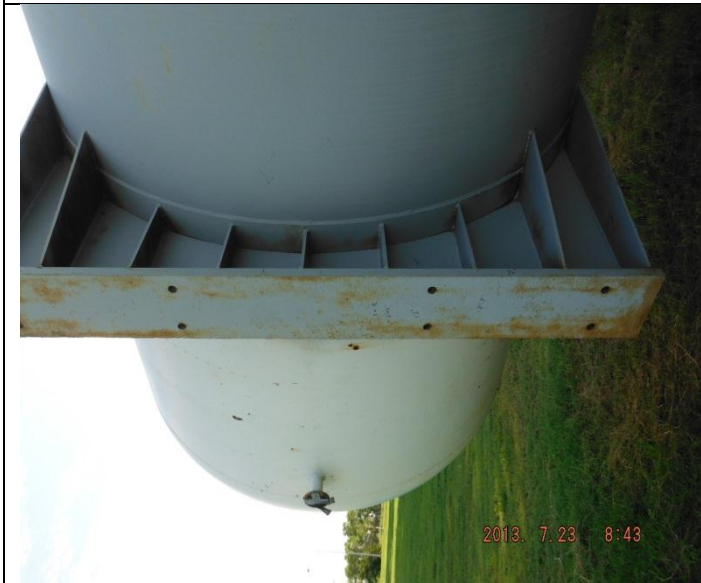
Saddle Support

There are 3 saddles supports for this vessel. Each support has a reinforcement band ¼" thick by 9" wide completely encompasses the full circumference of the vessel. The supports are located near each end and in the center. There were no visible distortions and the supports appear to be in serviceable condition.

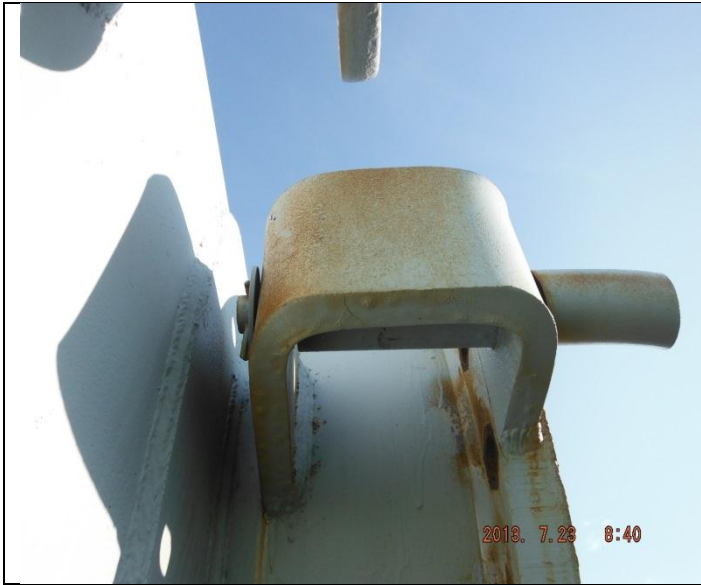
Davit Arm bracket

The manway had a heavy atmospheric scale build up on the flange area around the OD of the raised face sealing surface. The sealing surface was in serviceable condition. The scale can be scraped off with a hand scraper. The manway davit arm had been cut off previously leaving only the davit arm hinge clip and a partial remnant of the davit arm inserted into the clip.

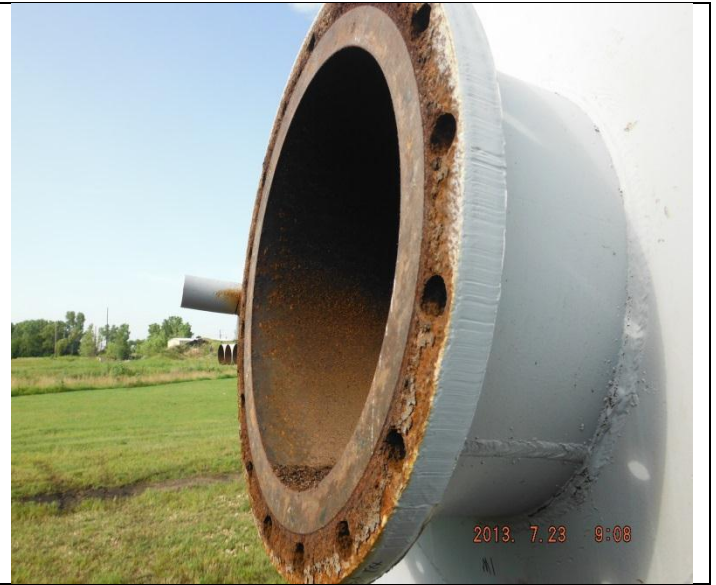
Man Way

Manway: The internal surface of the manway displayed no pitting. It had a light surface scale of approximately 10 mils thick. It did not indicate any signs of bulging, blistering or warping. The ID nozzle to shell weld was full profile with no preferential corrosion visible. The weld surface was similar to the nozzle ID surface.

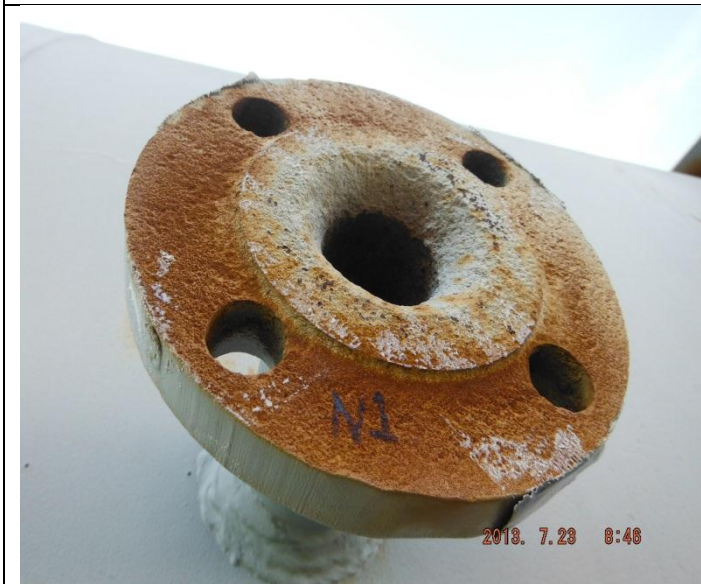
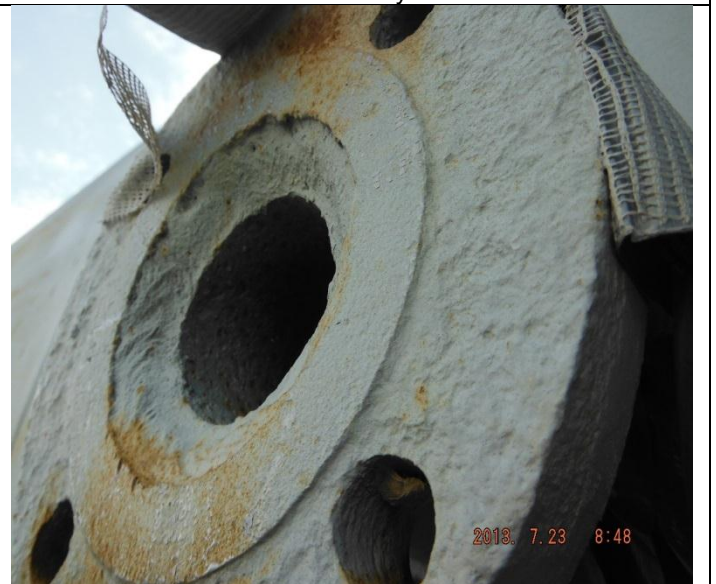
The nozzles necks were in serviceable condition however the flange sealing surfaces had a tightly adhered combination of atmospheric scale and paint approximately 20 mils thick. The pitting was not evaluated on the sealing surface due to the heavy scale build up. Nozzle labeled N3 had a visible RMS finish under the heavy scale while all of the other flange seating surfaces had no visible serrations. There were reinforcement pads installed on the 6" nozzle and the manway. All the repads had metallic threaded plugs installed in their telltale holes. Inspection of the telltale holes could not be performed.

Corroded Flange Face

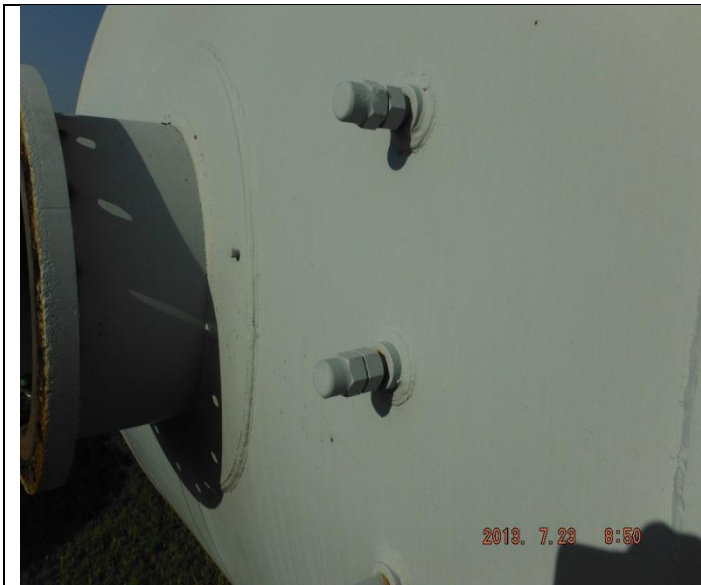
Couplings welded to shell

A 2" nozzle on the north east side had a valve and blind installed. Inspection of this nozzle was limited to the ID surface only, It had a heavy rust and scale build up which impeded the ID inspection of the surface. All nozzles, including threaded couplings, were internally back-welded and have some internal projection. All welds are full and complete with no visible porosity, cracking, or discontinuities that would affect the pressure retaining capabilities. Nozzle necks are free from debris and corrosion. All ID nozzle weld surfaces were comparable to the adjacent shell surfaces.

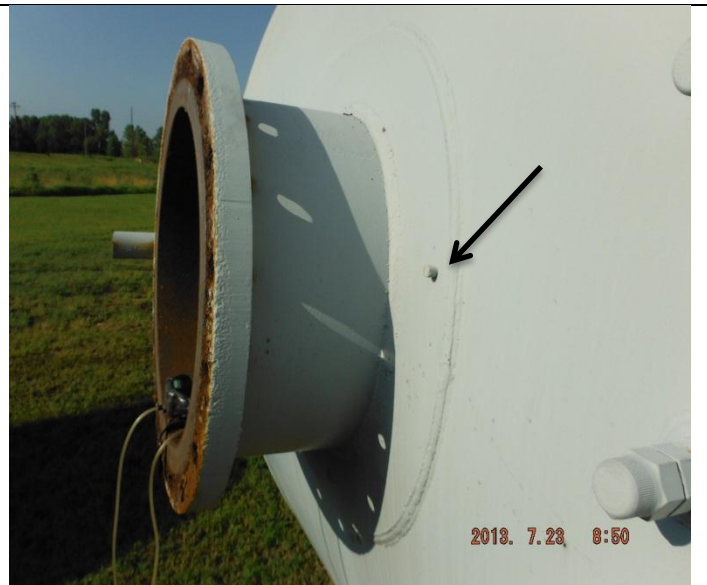
Repad plugged with threaded plug

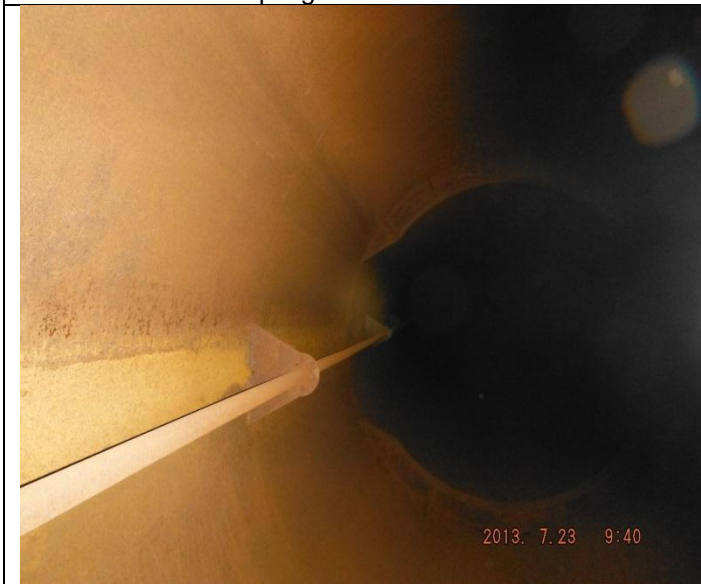
Distributor Pipe

A distributor pipe was installed on the south west end of the vessel and traveled to the north for the entire length to the vessel. The north end of the distributor header (approximately 15 foot) had 1/16" holes on the bottom of the pipe. The holes were 2" apart in a linear row. 95% of the holes completely were plugged.

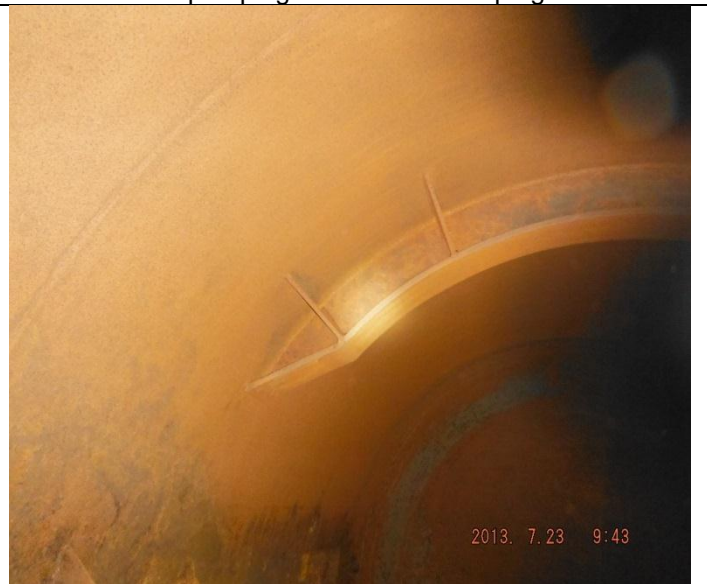
The shell internal surface was generally smooth with no measurable pitting. There was a light surface oxidation throughout the entire ID of the vessel. The welds were full profile and comparable to the shell surface ID.mm There are 3 internal stiffening rings welded to the shell for the entire ID circumference that are ½" thick X 6" in height.

ID Stiffener support for saddles (typ 3)
